Case Studies in Forensic Geotechnical and Foundation Engineering

CASE STUDIES IN FORENSIC GEOTECHNICAL AND FOUNDATION ENGINEERING

D.S. “Sax” Saxena, P.E., F.ASCE

ASC geosciences, inc.

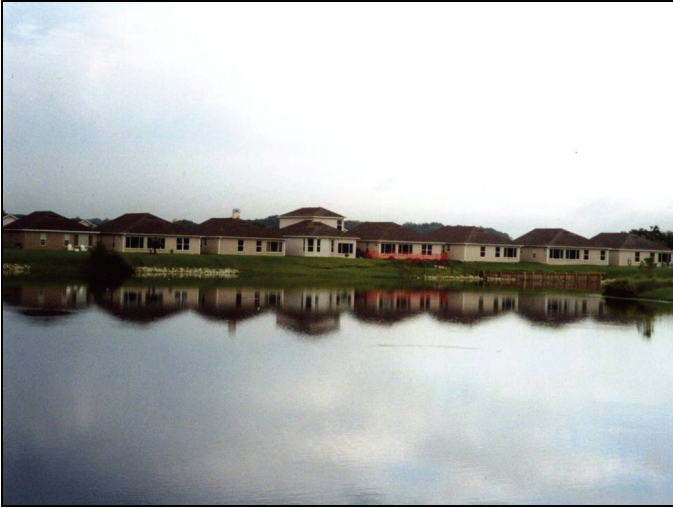
- the backyard slope of a one-story dwelling subsided abruptly, failed, and slid into the lake along with the rip-rap from lake edge. It also extended into the neighboring property on the south side.

- the lakefront backyard of a residence was damaged and stability of the structure was threatened.

Fig. 13. Panoramic view of the affected residences.

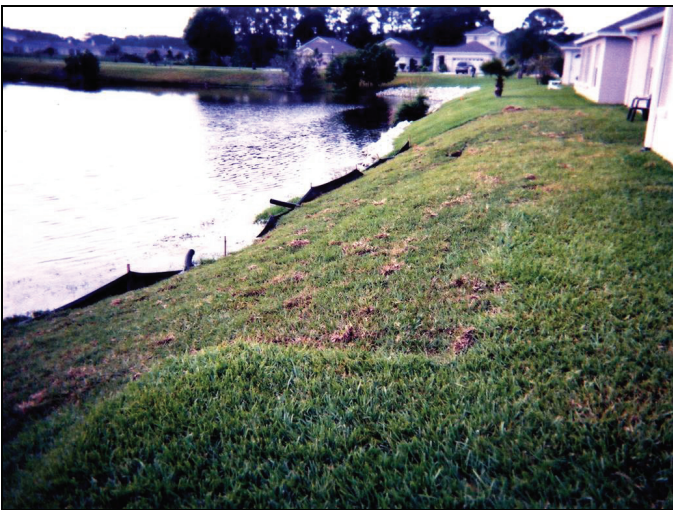
Fig. 15. View of sodded and finished backyard.

- slope failure was triggered by the presence of unconsolidated sediment layers under the site fill.
- unstable sediments will continue to consolidate resulting in continued movement of the back of the house and the backyard.
- a retaining wall should have been constructed prior to the house being built to contain and stabilize the soils beneath the house foundation.
